# **Middleton Flood Study**

## **Flood Mitigation Assessment Report**

**Alexandrina Council**

23 January 2024  
Ref: 230477R002B

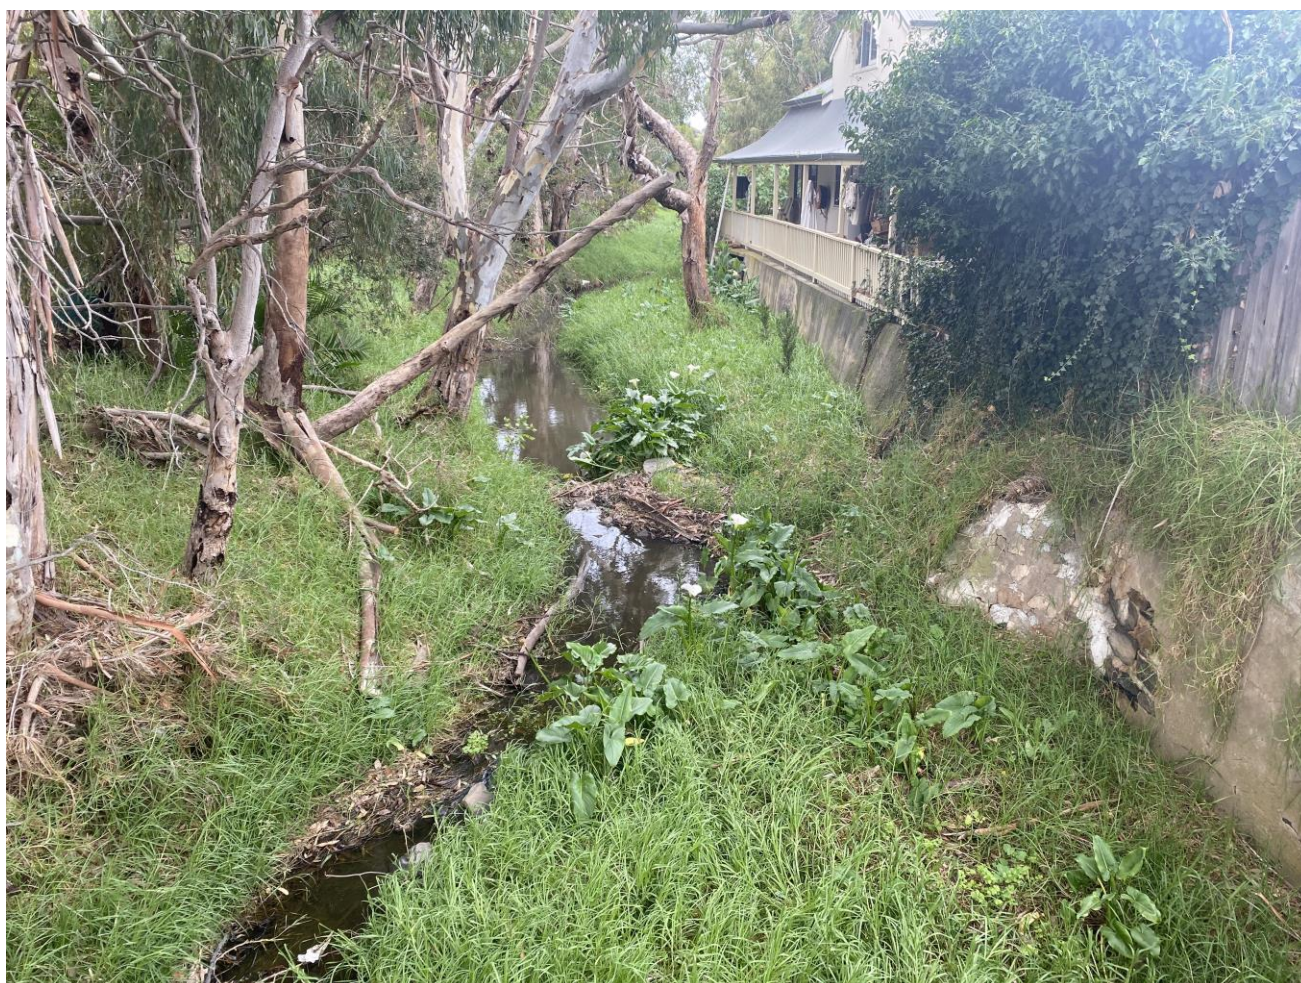
**Figure 2-2: Typical Vegetation in the creek in Middleton (looking south from Goolwa Road)**

The reaches of the creek within Middleton are fairly densely vegetated, with reeds and grasses along the base of the creek and numerous trees along the banks of the creek, especially between Goolwa Road and the Mill Terrace/Padman Crescent footbridge. See Figure 2-2 below for a photograph taken during the site visit.

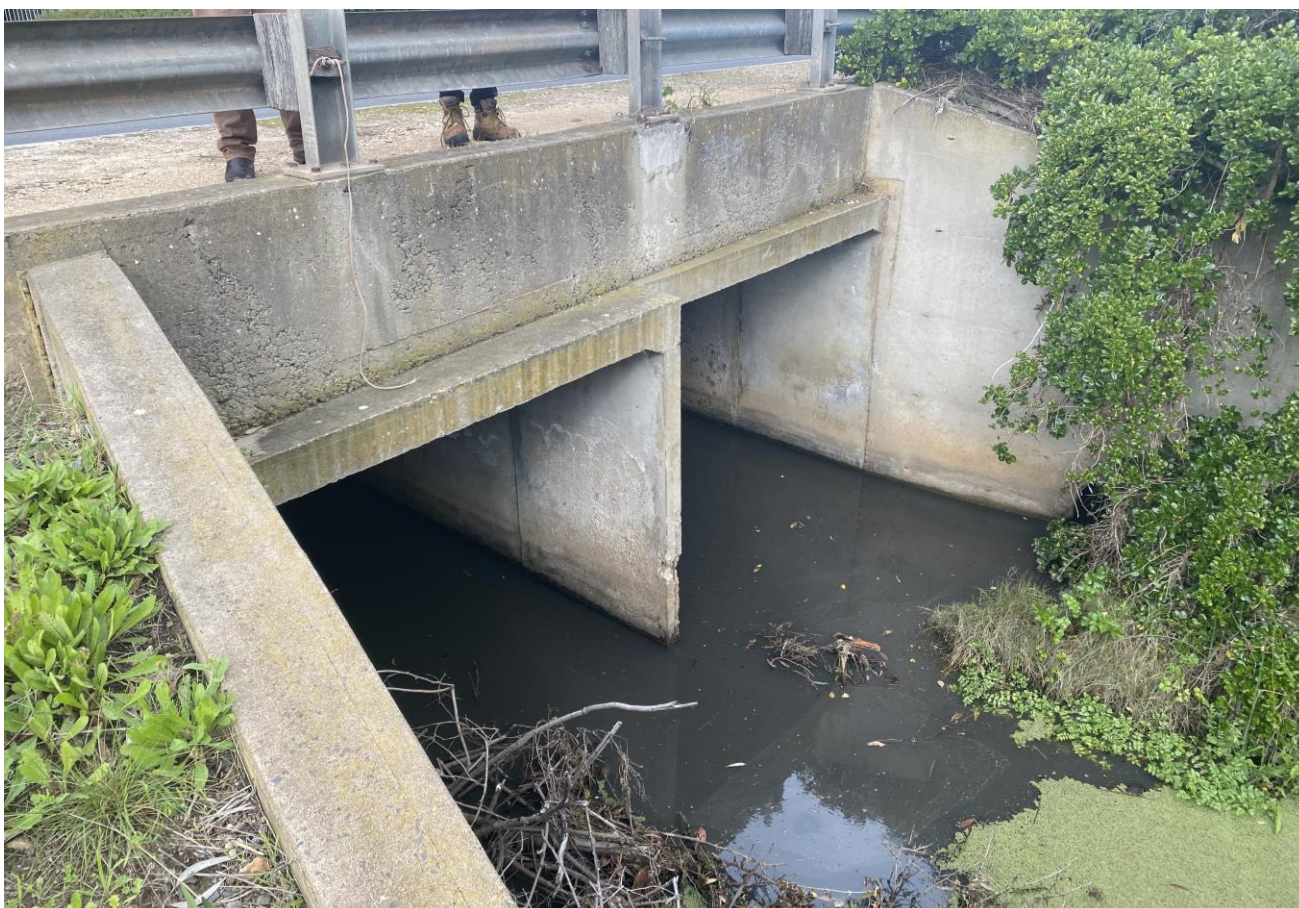
**Figure 2-3: Goolwa Road culverts (upstream side)**

The photo shown below in Figure 2-3 was fairly typical in terms of the level of transportable debris that was observed within the creek and through the catchment nearby to the creek. Overall, the amount of debris that may contribute in a “typical” event was fairly moderate. No sources of large rubbish (e.g. mattresses, shopping trolleys) upstream of the bridge were observed, and the majority of debris arriving at the culverts are relatively small branches and sticks.

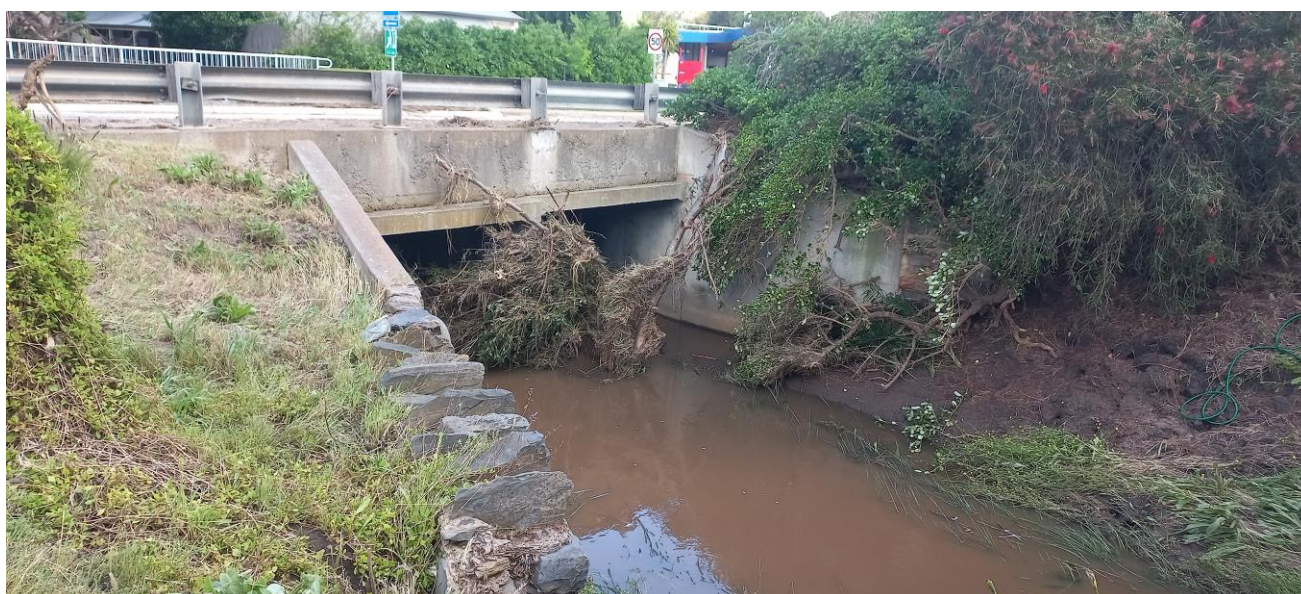
**Figure 2-4: Tree branch against the Goolwa Road culverts**

It is understood that during the November 2022 floods, the Goolwa Road culverts did become partially blocked due to tree branches becoming pinned against the central dividing wall between the culverts. Figure 2-4 is a photograph of a tree branch that remained against the culverts following the November 2022 floods.

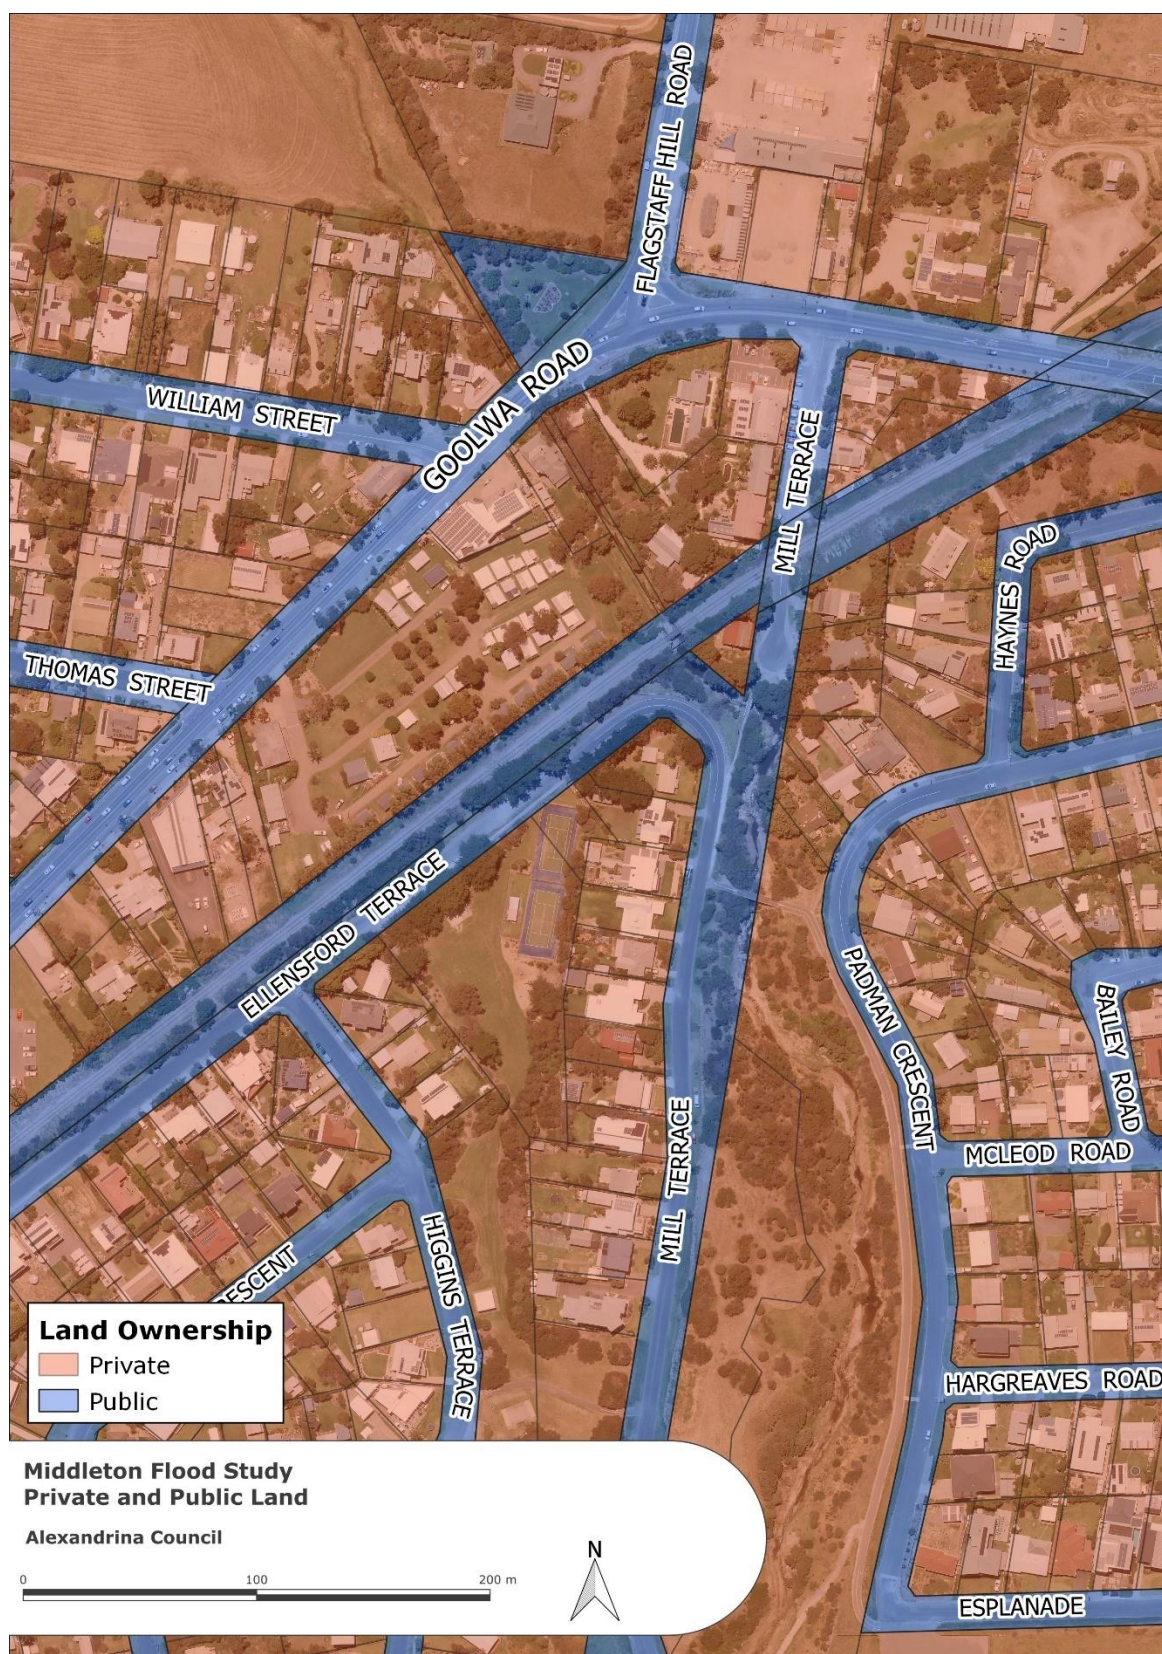
**Figure 7-1: Land ownership in Middleton**

A number of the mitigation options require access to the creek. However, at present the majority of this land is privately owned with no easement, with only a small block of land east of the creek publicly owned apart from the road corridor. This means therefore that many of the mitigation options will require land access approvals, creation of a drainage easement or purchase of private property. Figure 7-1 below shows the demarcation between public and private land.

It should be noted that similarly to the creek clearing option, the majority of the land in which widening would be undertaken is private property and so this will require landholder acceptance or even acquisition of private property.

It should be noted that as with the previous two options, much of the space required lies within private property and landholder approval would be required.

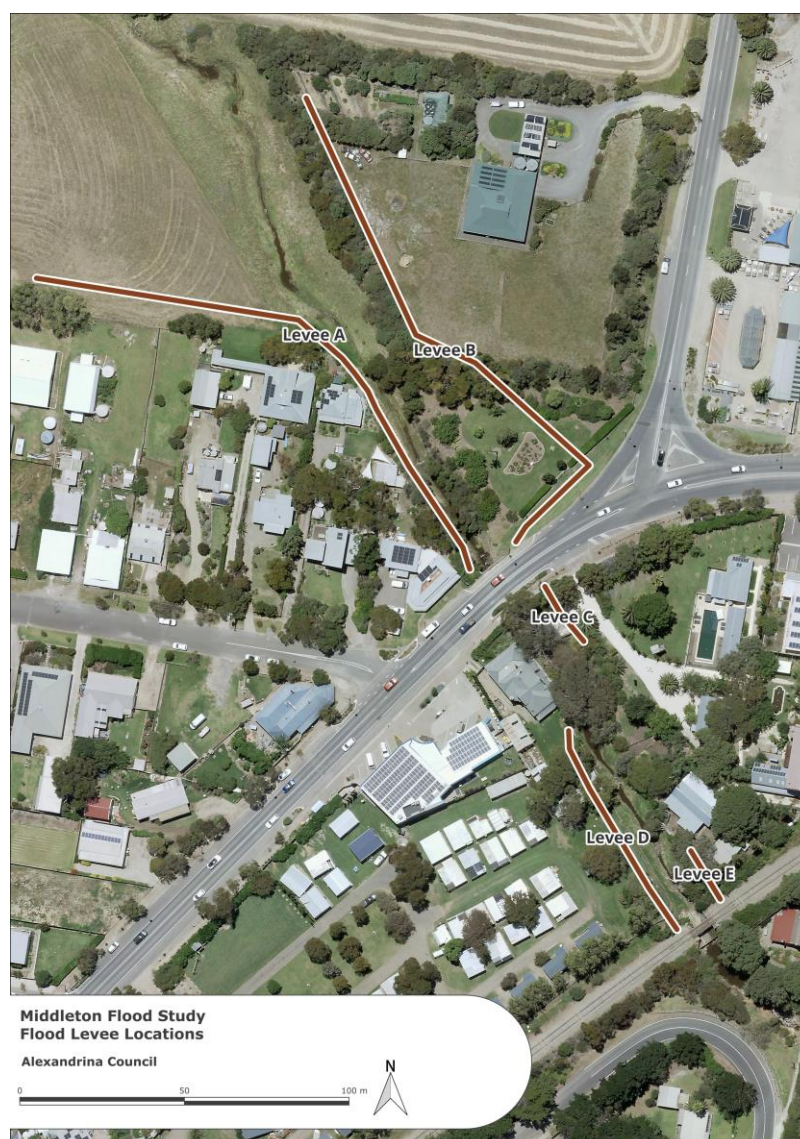
**Figure 7-3: Approximate locations of potential flood levees**

In some locations, there would be adequate room (pending approval from landholders) to construct an earthen levee. In other locations, owing to a lack of space between the creek banks and buildings, a vertical flood wall would need to be constructed. The locations of the levees are shown below in Figure 7-3.
